Manhole Inspection Summary

Manhole # S47CC_011MH

Insp Date: **2/7/08 8:42 AM**

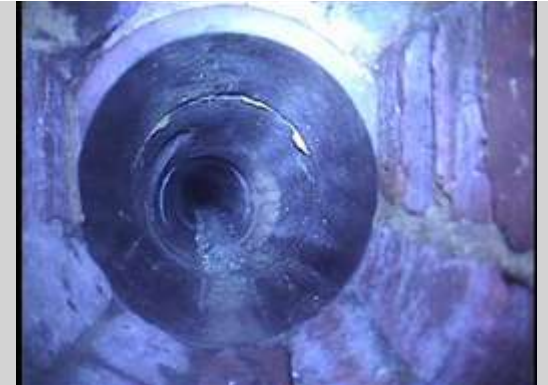
12 O'Clock Outflow

8 in. Circular Gravity Sewer
Pipe Out @ 12 O'Clock

Pipe Height: **8.4** (in.) Rod and Bar (Angled)

Pipe Material: **Clay** ☐ Pipe Lined

Invert Depth: **8.80** (ft.) Flow Characteristics: **None**

Infiltration: **None** Pipe Seal Cond: **Sound**

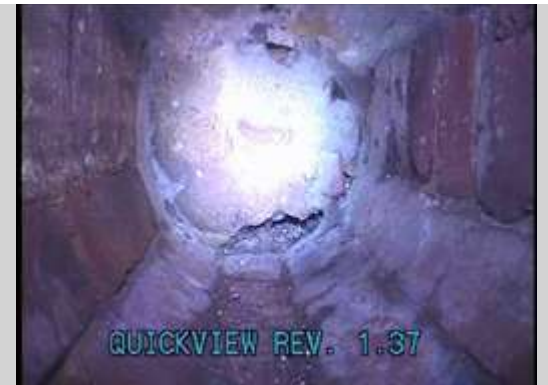
6 O'Clock Inflow

8 in. Circular Gravity Sewer
Pipe In @ 6 O'Clock

Pipe Height: **8.4** (in.) Rod and Bar (Angled)

Pipe Material: **Clay** ☐ Pipe Lined

Invert Depth: **8.70** (ft.) Flow Characteristics: **None**

Infiltration: **None** Pipe Seal Cond: **Sound**

Connects To: **Stub connection / abandoned**
